Metrorail Track Inspections

QICO Internal Review

June 9, 2017

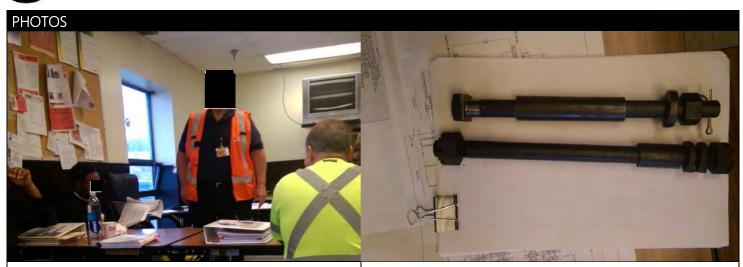
Figure 1: Morning Introduction (Date: 03/29/17 Time: 0726)

Figure 2: Bolt Comparison of Old vs. New Style (Date: 03/29/17 Time: 0753)

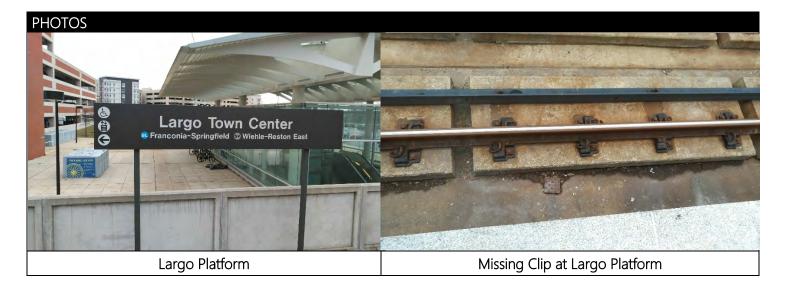
KEY OB	KEY OBSERVATIONS				
Item Nu	umber	Observation			
1		Platform Inspection			
	а	The walk began at the platform. The inspector informed that foul time must be called in order to inspect the platform track because there is no clear area (clearing under the platform is only to be done in an emergency situation so does not remove the need for foul time). This lead to inspecting only from the raised platform on a regular basis.			
	b	Where this may be sufficient in some circumstances this should not be the regular method of inspection. It is difficult to see the field side of the far rail and its fasteners.			
	С	A defect (missing clip) was noted on the visible portion of the track during the platform observation on the observable field side.

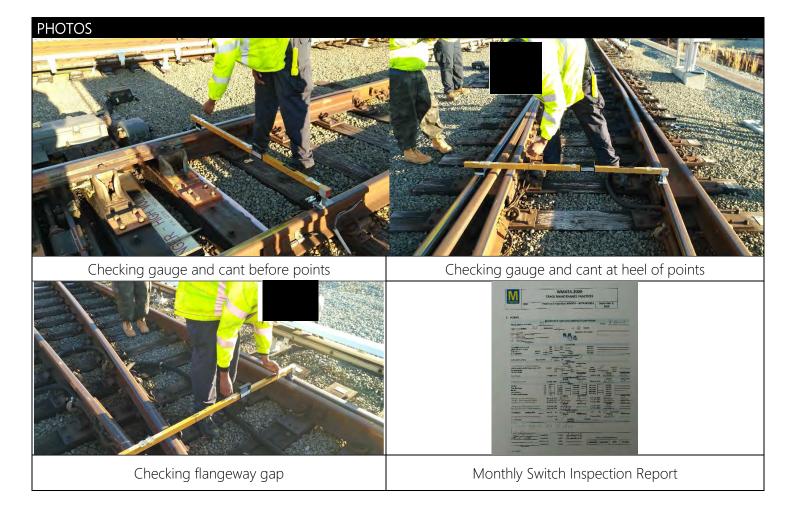
KEY O	KEY OBSERVATIONS			
Item Number		Observation		
6		Switch 165 Inspection		
	_	The walk began at switch 165. The RWIC called the yard operator and received permission enter the		
	а	ROW.		
		The inspector used a track gauge to check gauge, cant, and flange-way at the points, the toe of the		
	b	frog, the point of the frog, and the heel of the frog, on both the straight and switch side of the		
		turnout.		
	_	The other inspector recorded the information and did a brief visual inspection of the switch before		
	С	moving on to the other switch being inspected.

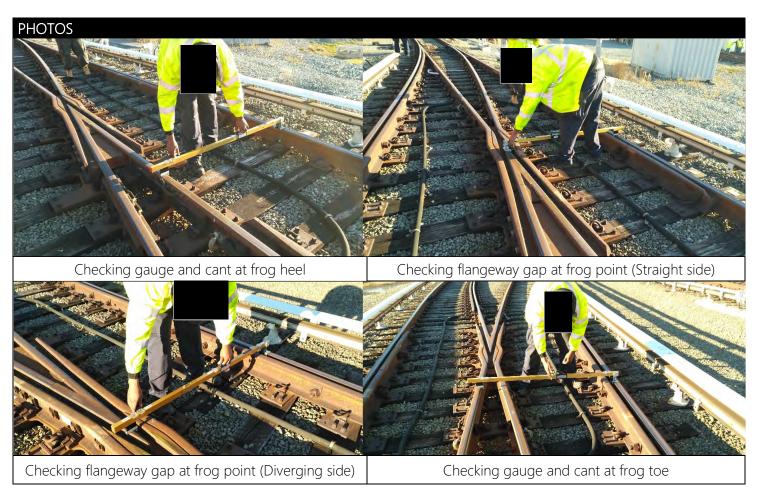
KEY OB	KEY OBSERVATIONS		
Item Nu	umber	Observation	
7		Switch 167 Inspection	
		After complete the inspection of switch 165 the inspectors moved to the neighboring track to	
	а	inspect switch 167. The RWIC called the yard operator to inform the inspection was changing tracks	
		and received permission.	
		The inspector used a track gauge to check gauge, cant, and flange-way at the points, the toe of the	
	b	frog, the point of the frog, and the heel of the frog, on both the straight and switch side of the	
		turnout.	
		The other inspector recorded the information and did a brief visual inspection of the switch before	
	С	completing the walk.
